Reserve Study

Level I, Full

Lakeshore Club Of Polk County

FPAT File#: RES2524793

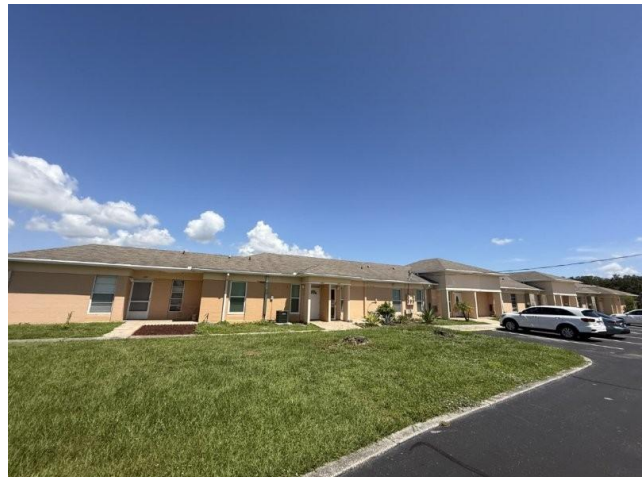
Unit Cost (01/01/2026): \$13.50
 Total Qty to Maintain (100% of Total): 25,255 LF
 Total Current Cost: \$340,942
 Inflation Rate: 2.50%
 Condition: Good to Fair

Reserve Item	Service Date	Replace Date	Rem Life	Adj Life (+/-)	Qty	Current Cost	Future Cost
Gutters & Downspouts, 6" Aluminum	01/01/2010	01/01/2040	14y	0y	25,255 LF	\$340,942	\$481,742
Total					25,255 LF	\$340,942	\$481,742

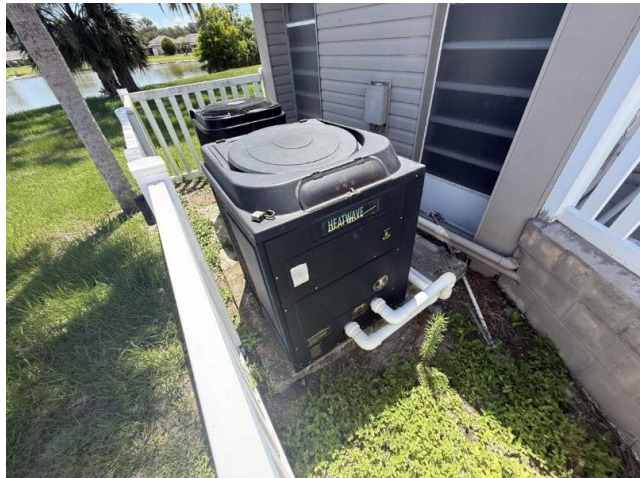
Basic Info		Cost Data	
Asset ID:	C07	Unit Cost (01/01/2026):	\$5,500.00
Type of Cost:	Replacement	Total Qty to Maintain (100% of Total):	1 Ea
Category:	Pool Facility Components	Total Current Cost:	\$5,500
Sub-Category:		Inflation Rate:	2.50%
Est. Useful Life:	8y	Condition:	Good

Reserve Item	Service Date	Replace Date	Rem Life	Adj Life (+/-)	Qty	Current Cost	Future Cost
Spa Heater, Gas, 399K BTU	01/01/2024	01/01/2032	6y	0y	1 Ea	\$5,500	\$6,378
Total					1 Ea	\$5,500	\$6,378

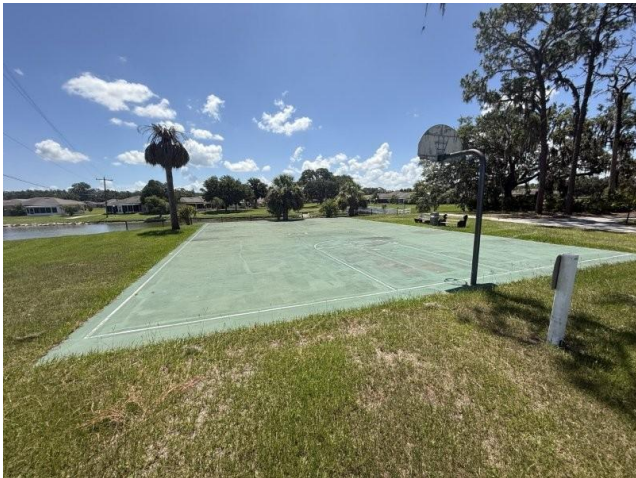
Basic Info		Cost Data	
Asset ID:	D14	Unit Cost (01/01/2026):	\$1.95
Type of Cost:	Replacement	Total Qty to Maintain (100% of Total):	4,000 SF
Category:	Property Site Components	Total Current Cost:	\$7,800
Sub-Category:		Inflation Rate:	2.50%
Est. Useful Life:	6y	Condition:	Fair

Reserve Item	Service Date	Replace Date	Rem Life	Adj Life (+/-)	Qty	Current Cost	Future Cost
Basketball Court, Color Coat, Refinish	01/01/2001	01/01/2029	3y	22y	4,000 SF	\$7,800	\$8,400
Total					4,000 SF	\$7,800	\$8,400

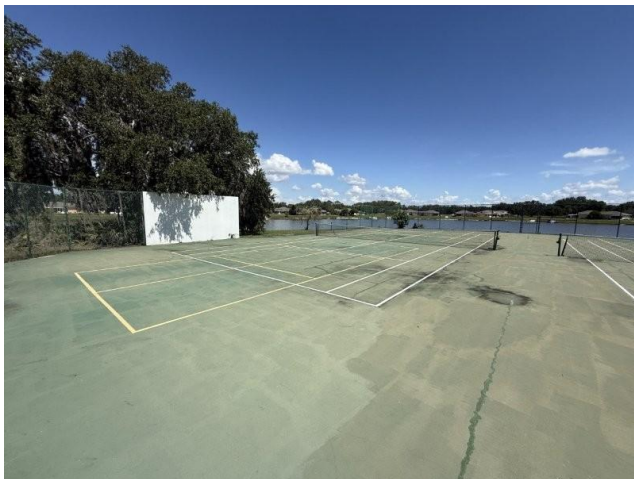
Reserve Item	Service Date	Replace Date	Rem Life	Adj Life (+/-)	Qty	Current Cost	Future Cost
Tennis Court, Color Coat, Refinish	01/01/2001	01/01/2029	3y	22y	12,600 SF	\$24,570	\$26,459
Total					12,600 SF	\$24,570	\$26,459

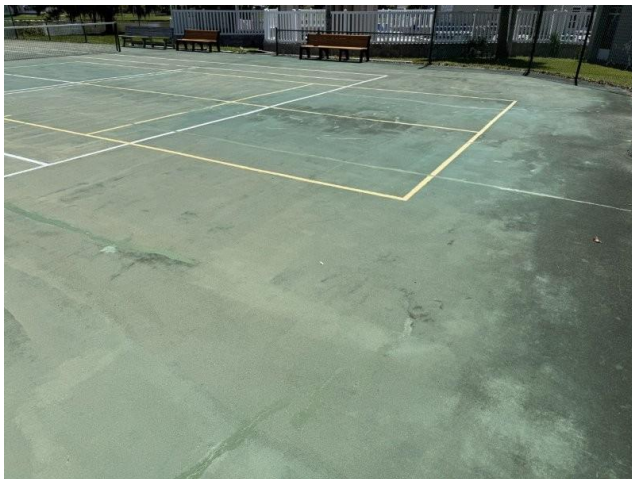
Reserve Item	Service Date	Replace Date	Rem Life	Adj Life (+/-)	Qty	Current Cost	Future Cost
Tennis Fence, VC Chain Link, 10'	01/01/2024	01/01/2049	23y	0y	358 LF	\$20,406	\$36,009
Total					358 LF	\$20,406	\$36,009

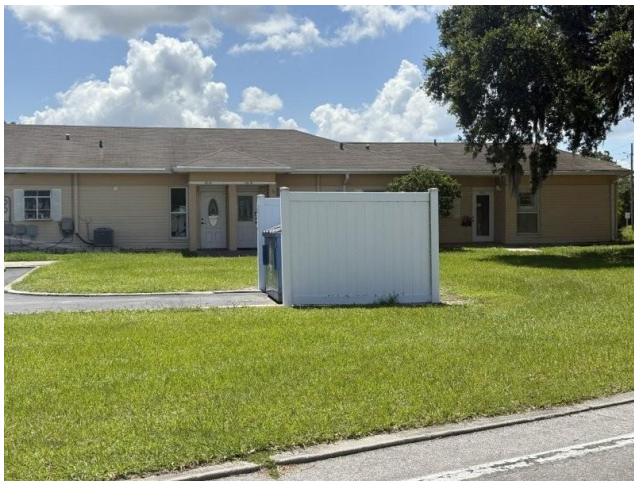
This report assumes the total of the HVAC equipment in the Town Center will be replaced in 2025 based on an email provided by the Board.

Reserve Item	Service Date	Replace Date	Rem Life	Adj Life (+/-)	Qty	Current Cost	Future Cost
HVAC, Split-System, 2 Ton	01/01/2025	01/01/2037	11y	0y	3 Ea	\$15,000	\$19,681
Total					3 Ea	\$15,000	\$19,681

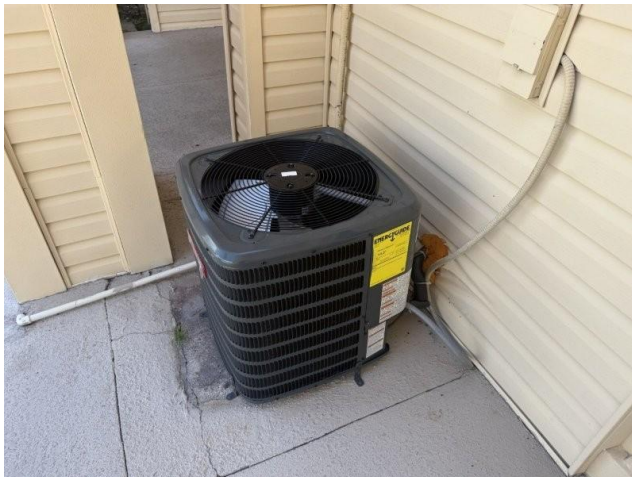
Basic Info		Cost Data	
Asset ID:	E02	Unit Cost (01/01/2026):	\$10,000.00
Type of Cost:	Replacement	Total Qty to Maintain (100% of Total):	1 Ea
Category:	Town Center Components	Total Current Cost:	\$10,000
Sub-Category:		Inflation Rate:	2.50%
Est. Useful Life:	12y	Condition:	Good

This report assumes the fall of the HVAC equipment in the Town Center will be replaced in 2025 based on an email provided by the Board.

Reserve Item	Service Date	Replace Date	Rem Life	Adj Life (+/-)	Qty	Current Cost	Future Cost
HVAC, Split-System, 5 Ton	01/01/2025	01/01/2037	11y	0y	1 Ea	\$10,000	\$13,121
Total					1 Ea	\$10,000	\$13,121
